**CASTLE**

**16 BARRINGTON STREET  
SOUTH SHIELDS  
TYNE AND WEAR  
NE33 1AN**

**SPECIFIC DEFECT SURVEY**

**FEBRUARY 2026**

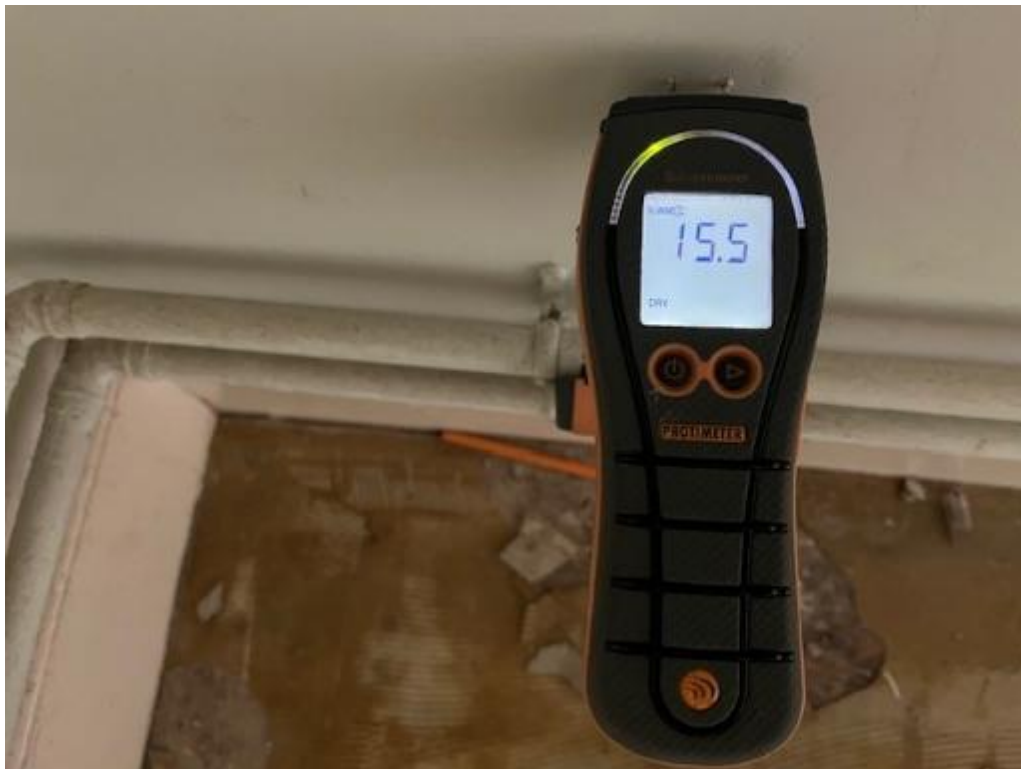
P44 – Director of Estates 15.5% m.c

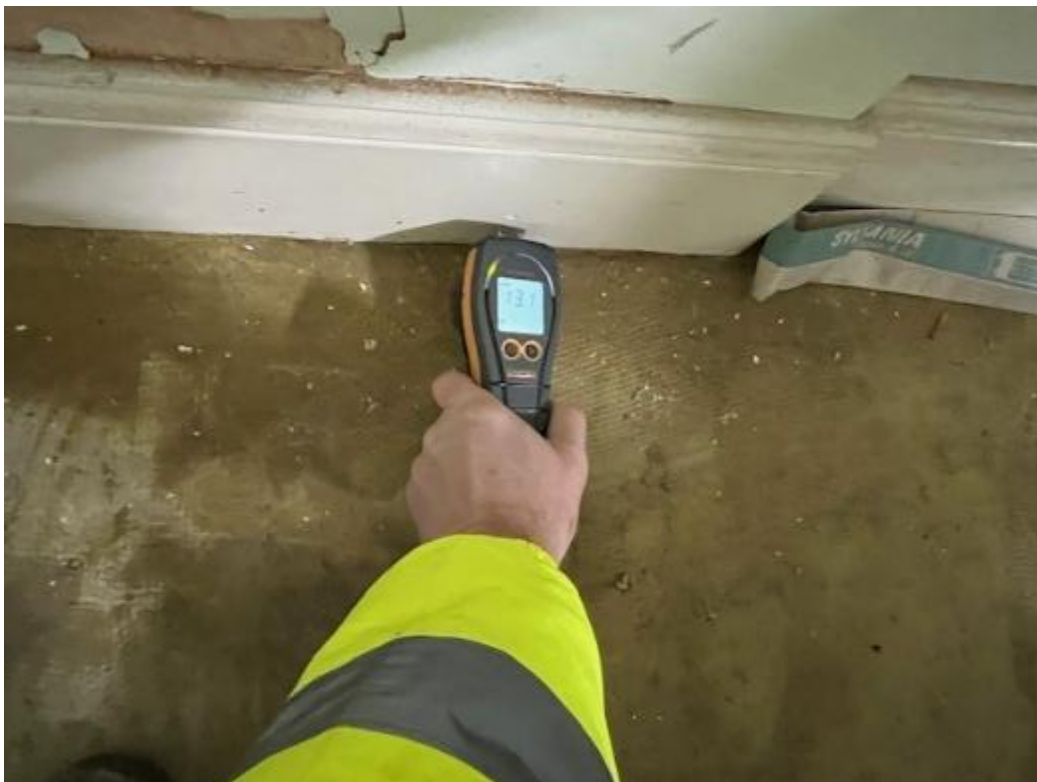
P48 – Skirting m.c 13.1 %

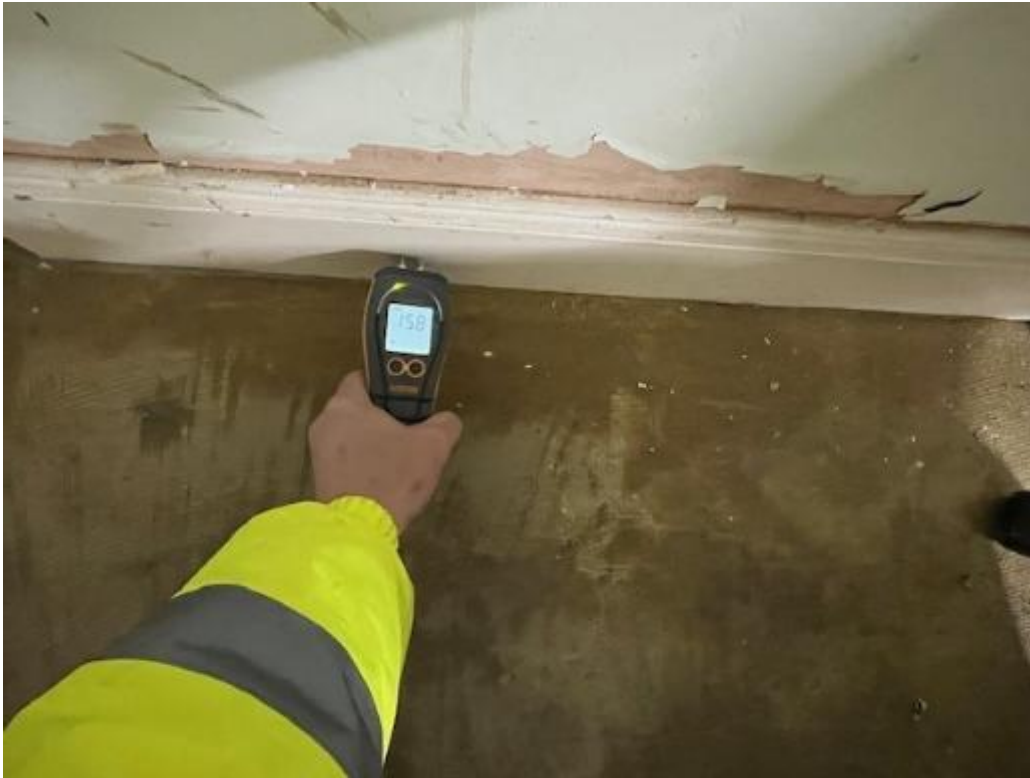
P49 – Skirting 15.8 % m.c

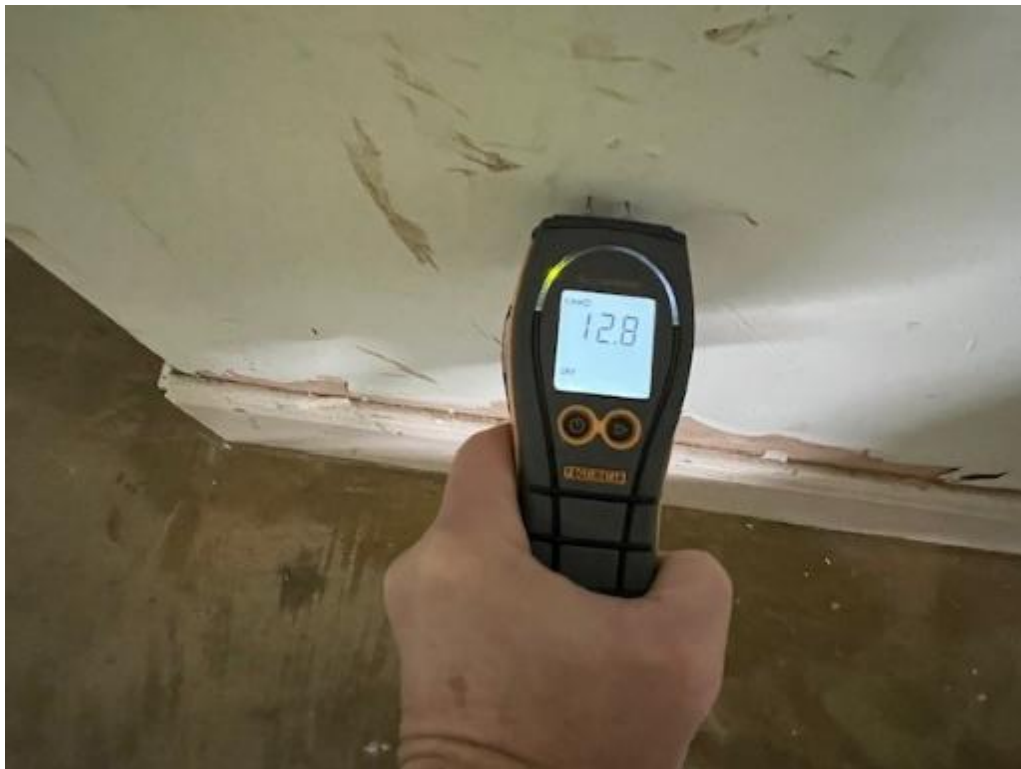
P58 – 12.8 % m.c

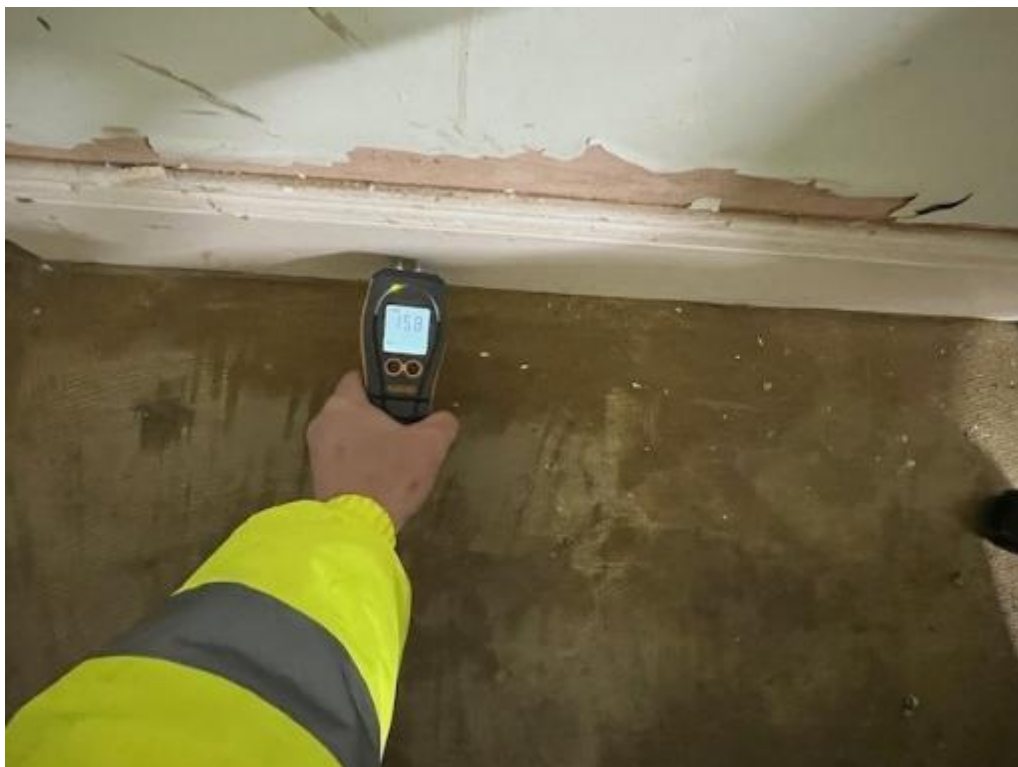
P63 – Skirting 15.8% m.c

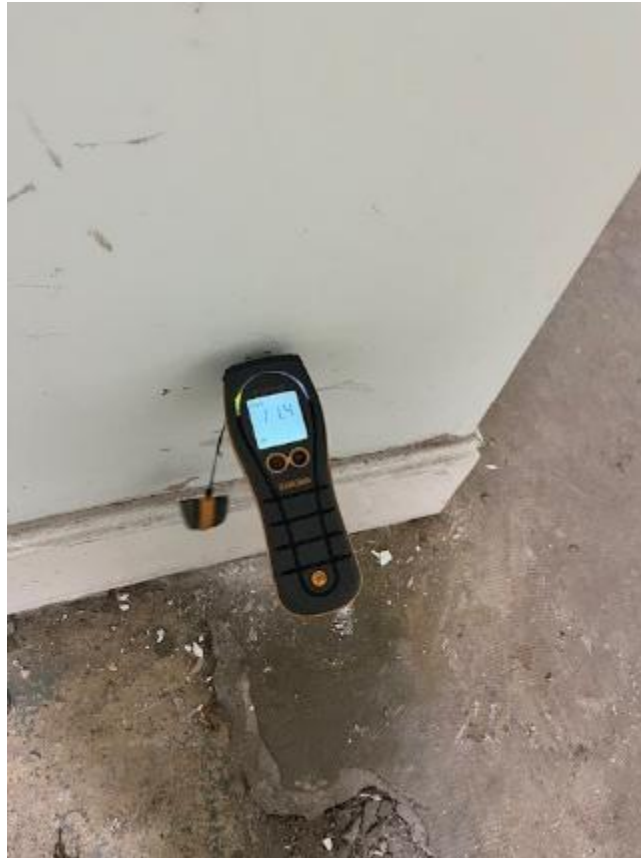
P68 – 17.4% low level

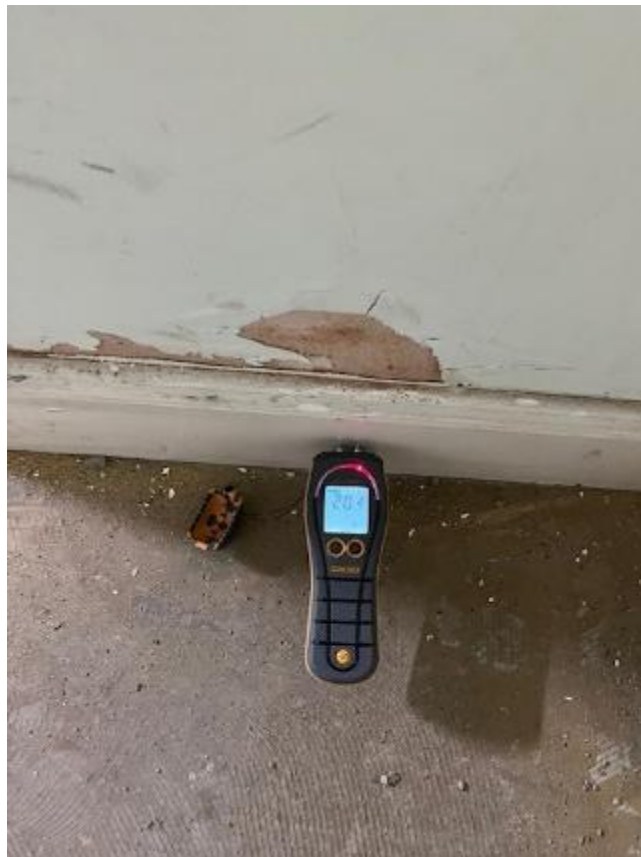
P69 – Skirting 20%

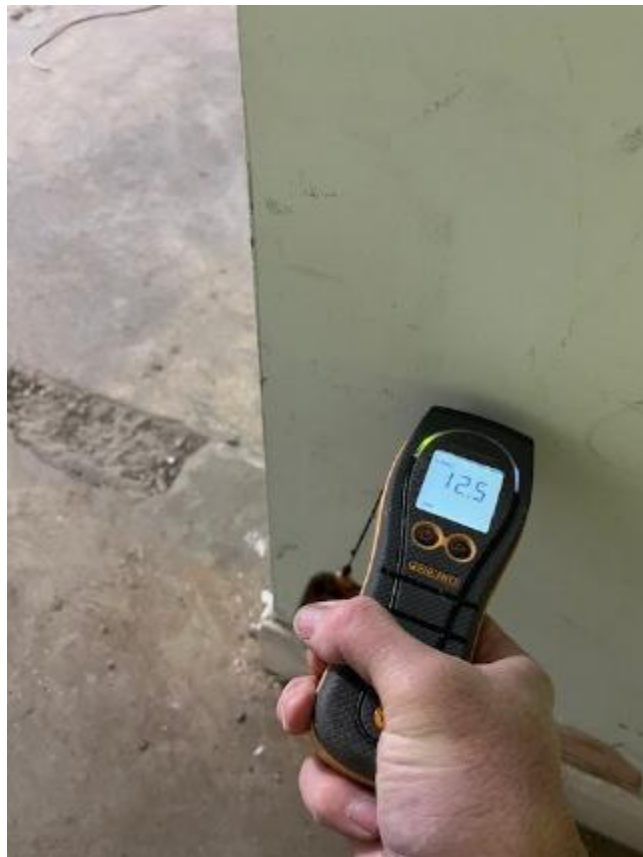
P71 – 12.5% m.c

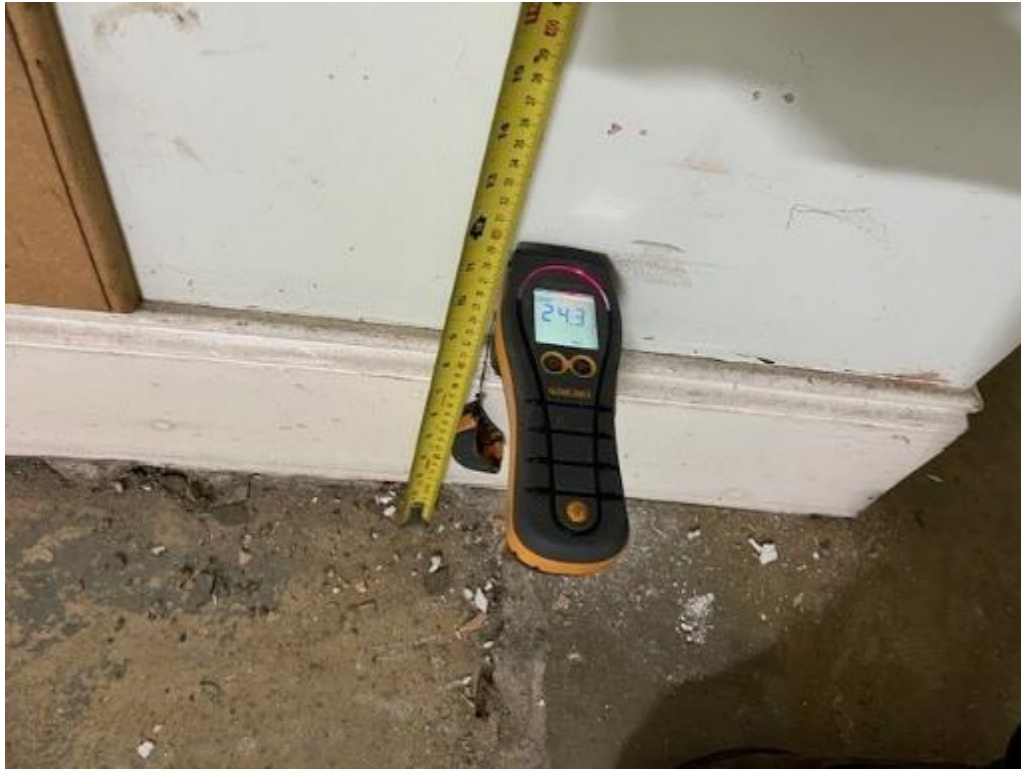
P72 - 24.3% mc

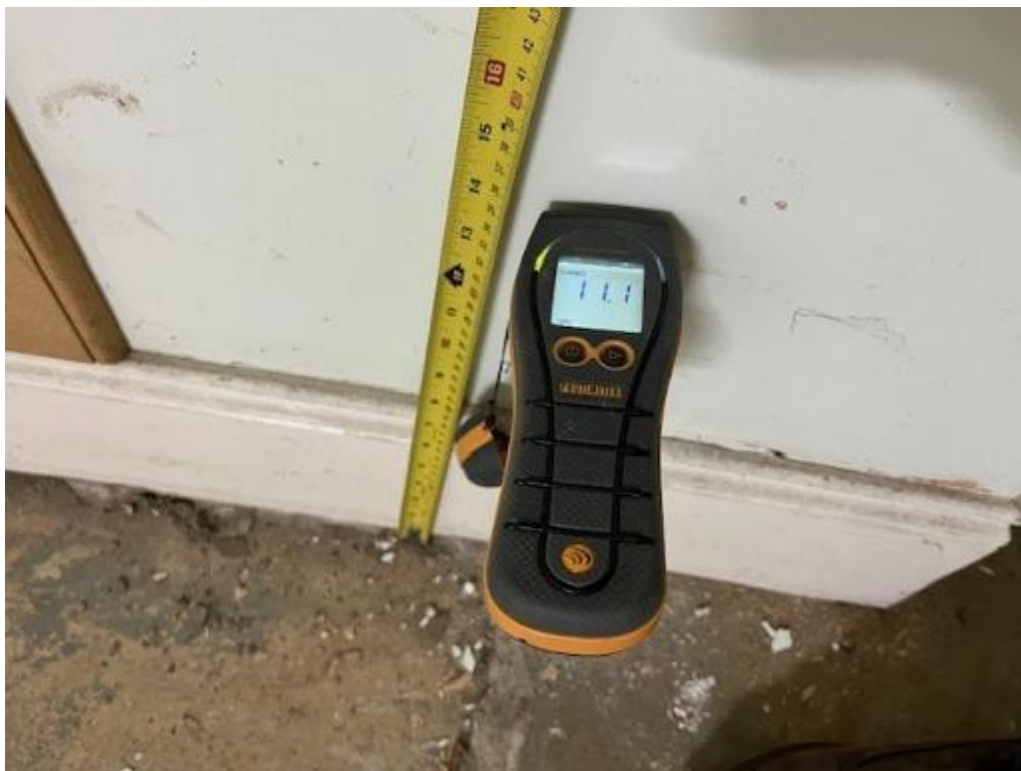
P73 – Moisture content reducing with height 11.9%
